To: Steve Gramm, Study Advisory Team	
From: Rick Laughlin	Project: I-190/Silver St.
CC:	
Date: 4/4/2011	Job No:

**RE:** Special event observation

HDR conducted an observation of special event traffic on 3/18 and 3/19, 2011 to determine special traffic demands posed by special events and the potential impacts within the study area for the Silver Street interchange. On those evenings, the following special events were occurring at the Rushmore Plaza Civic Center:

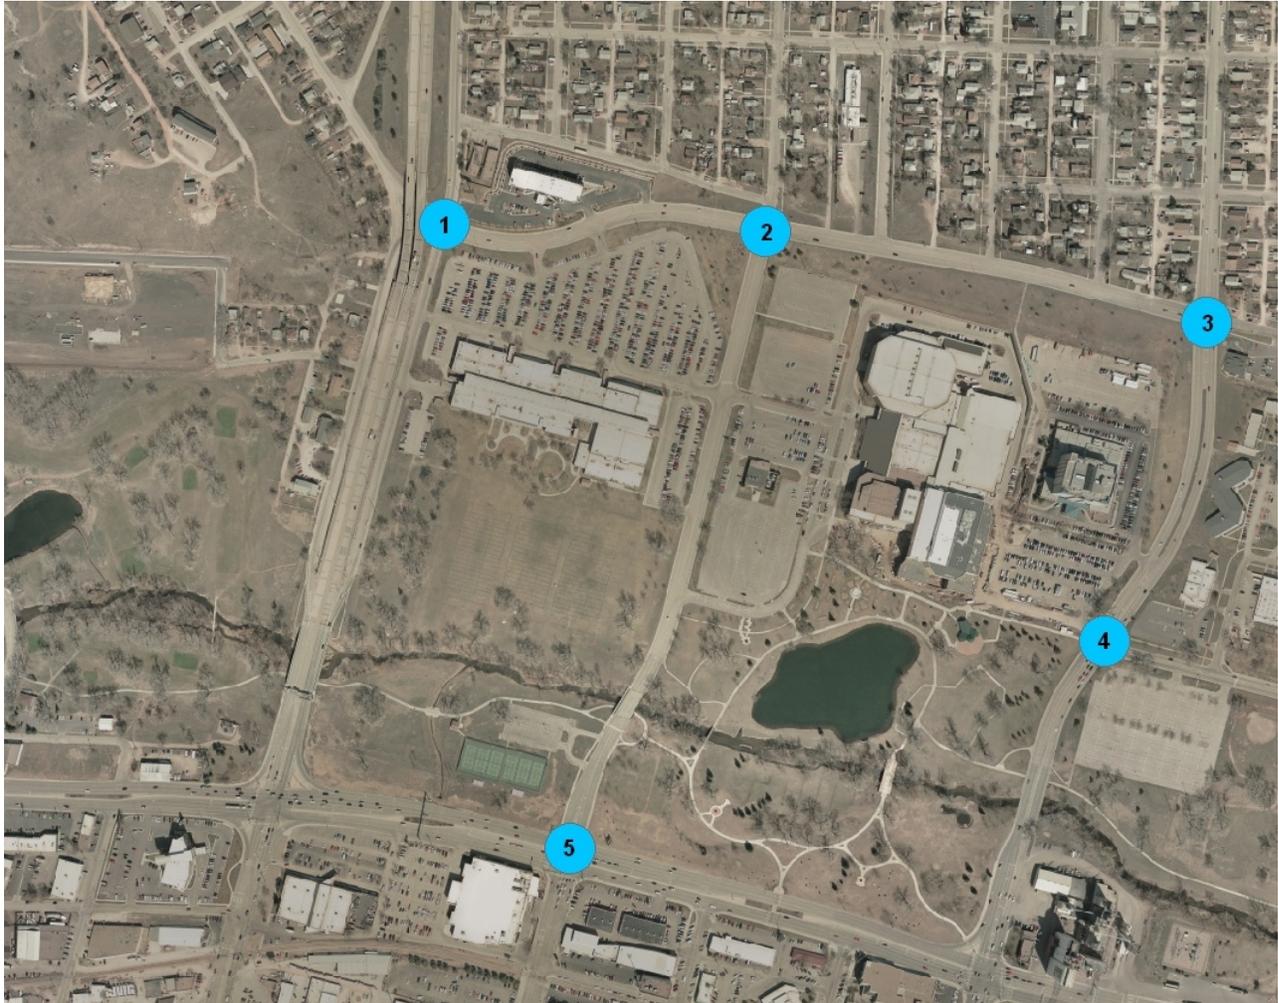
**Figure 1 – Special Event Observation Locations**

Observations were conducted at various locations around the Civic Center beginning at about 4:30 PM and continuing until after 10 PM. The locations included 1) the I-190/Silver Street interchange, 2) the North Street/Mt. Rushmore Road intersection, 3) the 5<sup>th</sup> Street/North Street intersection, 4) the 5<sup>th</sup> Street/New York Street intersection and 5) the Omaha Street/Mt. Rushmore Road intersection. The locations are also shown in Figure 1. Observation notes are attached to this memorandum for reference.
